**ST. ALBANS RESERVOIR DAM (SOUTH)
VT 00057**

**PHASE I INSPECTION REPORT
NATIONAL DAM INSPECTION PROGRAM**

SEPTEMBER 1978

Identification No.: VT00057
Name of Dam: St. Albans Reservoir Dam (South)
Town: Fairfax
County and State: Franklin County, Vermont
Stream: Unknown
Date of Inspection: August 3, 1978

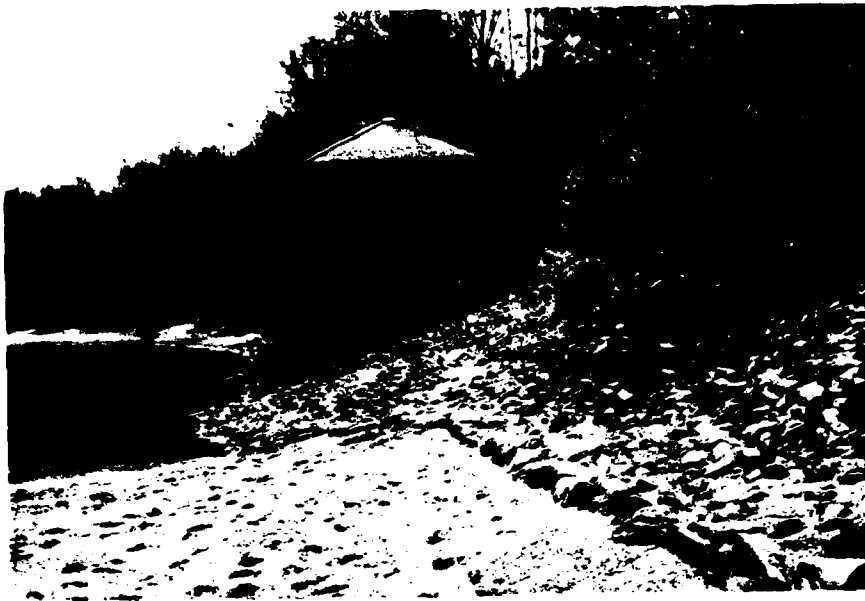
The gatehouse structure has numerous cracks in the concrete. The gate chamber was not observed as the entrance was blocked up. The outlet channel was the natural bed of the stream.

#3 GATEHOUSE AND RIPRAP ON UPSTREAM FACE OF DAM.
